Restoration of Deteriorated Air Handlers

CUSTOMER
University Facility

LOCATION
New Jersey

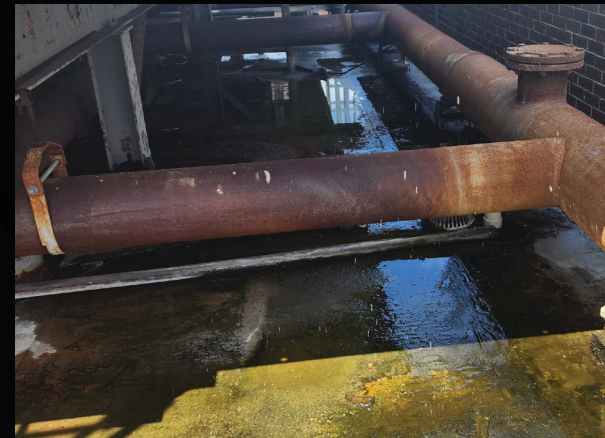
A severely deteriorated rooftop air handler was leaking water directly into an active animal research lab located below, posing significant risk to sensitive research operations and equipment. The air handler could not be easily replaced as adjacent train tracks made the roof inaccessible with a crane.

Fig. 1 Roof area below air handler

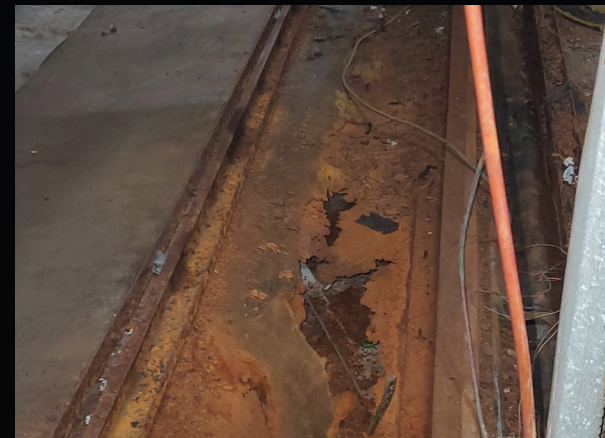
Fig. 2 Deteriorated air handler

1. The surface was prepared by scraping loose rust from surface and bristle blasting down to manufacturer recommendation.
2. Epoxy impregnated carbon fiber reinforced polymer (CFRP) materials were applied to reinforce weakened steel components and restore structural integrity.
3. A protective, flexible, odorless, and non-flammable coating system was installed to extend the service-life of the air handler.

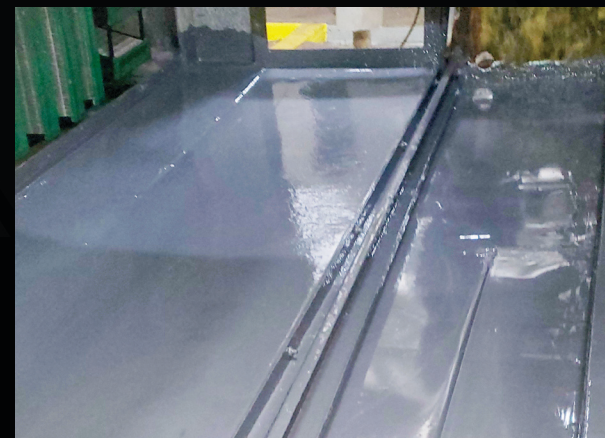
Fig. 3 Finished product
