Storm Sewer Structural Repair

CUSTOMER
NY Research Facility

DATE OF APPLICATION
August 2017

LOCATION
New York

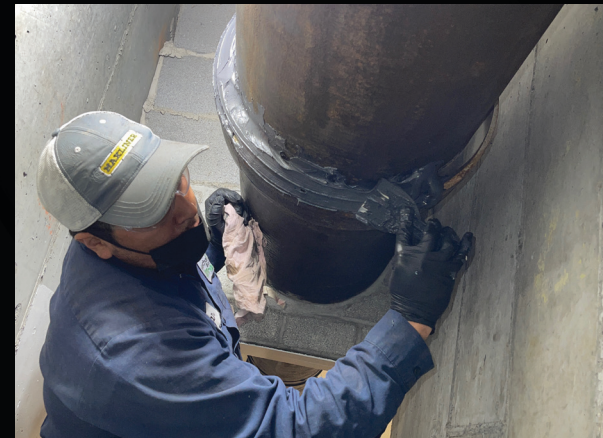
Fig. 1 Bell and spigot joint smoothed with repair putty

1. The surface of the pipe was prepared by bristle blasting the length of the repair.
2. Through-wall penetrations and multiple bell-and-spigot joints were prepped using a repair putty to provide a smooth wrapping surface, even over complex pipe geometry.
3. The composite wrap was installed along the entire length of the compromised pipe. The system was designed to bond directly to the cast iron substrate and provide additional hoop strength and structural stability.

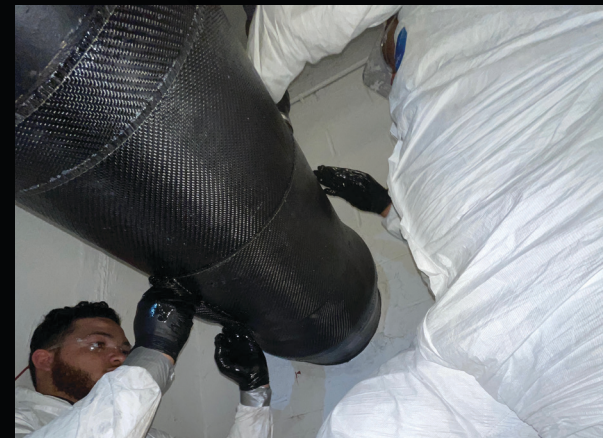
Fig. 2 Composite wrap installation

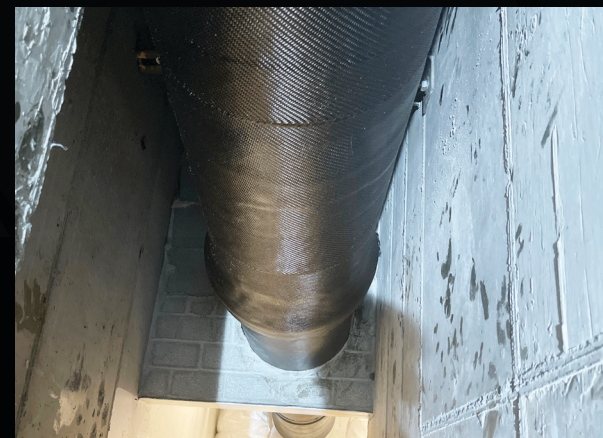
Fig. 3 Through-wall penetration after installation
