# Fast Cure UV Light Pipe Lining & Floor Repair

**CUSTOMER**  
Food Manufacturing Plant

**DATE OF APPLICATION**  
December 2025

**LOCATION**  
Poughkeepsie

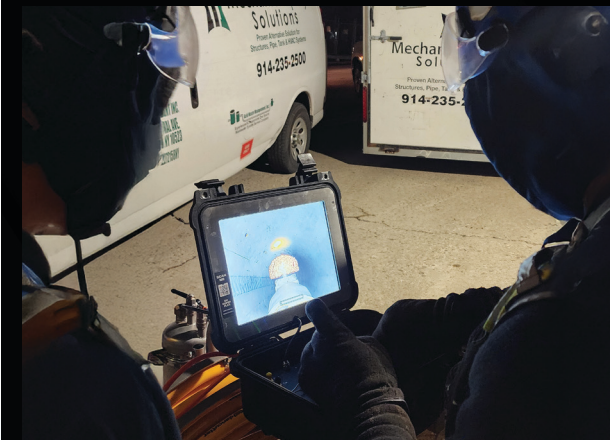
A national food manufacturing facility experienced recurring operational disruptions caused by a deteriorated underground sanitary piping system.

Working within the facility's limited shutdown schedule, MES performed a detailed inspection to identify the root causes of the deposit build up and flow inefficiency. A UV-cured CIPP (Cured-In-Place-Pipe) liner was recommended to repair the sanitary piping.

Fig. 1 Video inspection of pipe

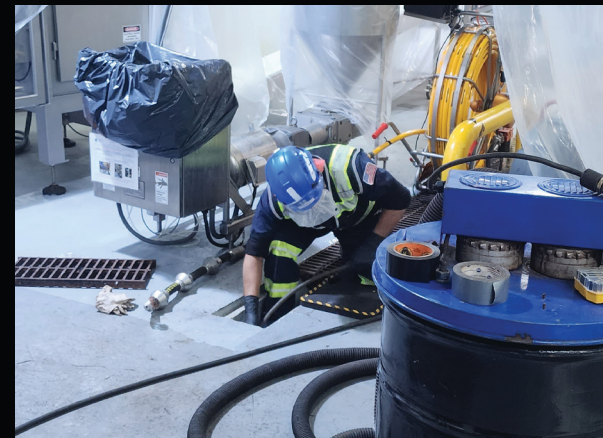
Fig. 2 Pipe being prepared for lining

1. Sections of piping were identified that were suitable for CIPP lining.
2. Non-destructive cleaning was performed to clear debris and restore the pipe sections to their original internal diameter.
3. A high-strength, UV-cured CIPP liner was installed within the host pipe. The liner was rapidly hardened using controlled ultraviolet light exposure, creating a structural, corrosion-resistant liner within the existing pipe.

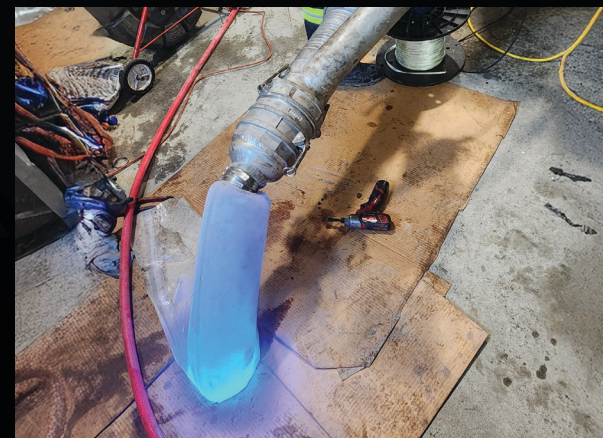
Fig. 3 UV-curing system
