Leaking Acid Neutralization Tanks & Piping

CUSTOMER
Medical Office

LOCATION
New York

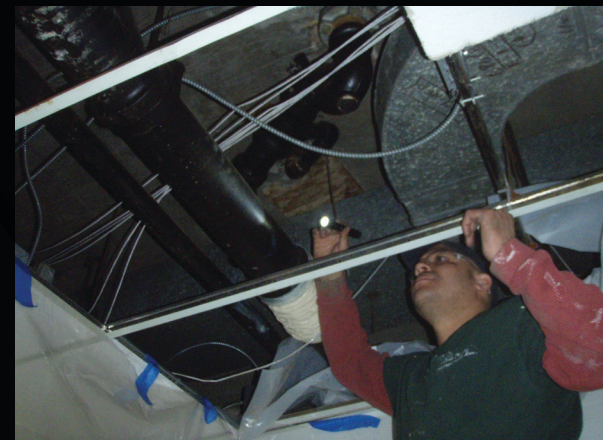
Fig. 1 Inspection of piping

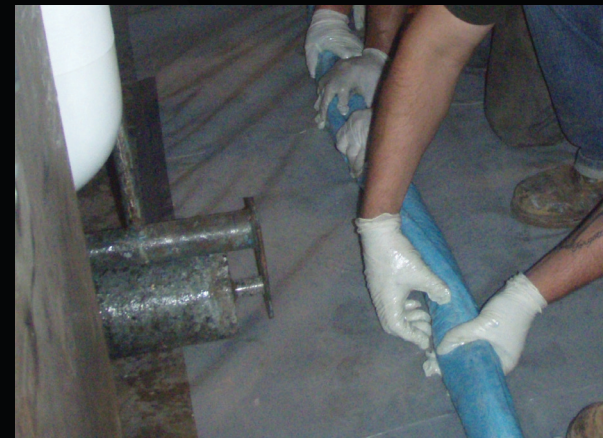
Fig. 2 Preparation of CIPP liner

1. A specialized non-destructive pipe cleaning was performed to restore piping to its original internal diameter.
2. Cured in place pipe (CIPP) liners were installed throughout 100% of the gravity sewer and laboratory waste piping, creating a new structural pipe within the existing system.
3. Technicians applied structural epoxy to the three cracked acid neutralization tanks, eliminating active leaks and extending the service life of the tanks.

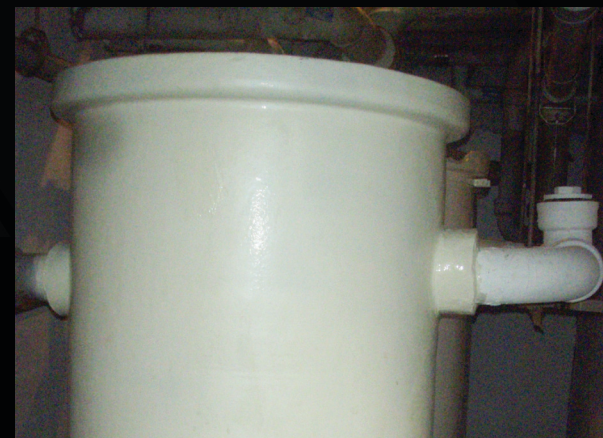
Fig. 3 Coated vessel
